# Importance of Earthquake-Related Detailing in Construction:

## Experiences from the Mandalay Earthquake in Myanmar

DR. SOE MYINT, PhD, PE  
ACPE ( Civil ), Thailand RFPE ( Civil )

27<sup>th</sup> June 2025  
Bangkok, Thailand

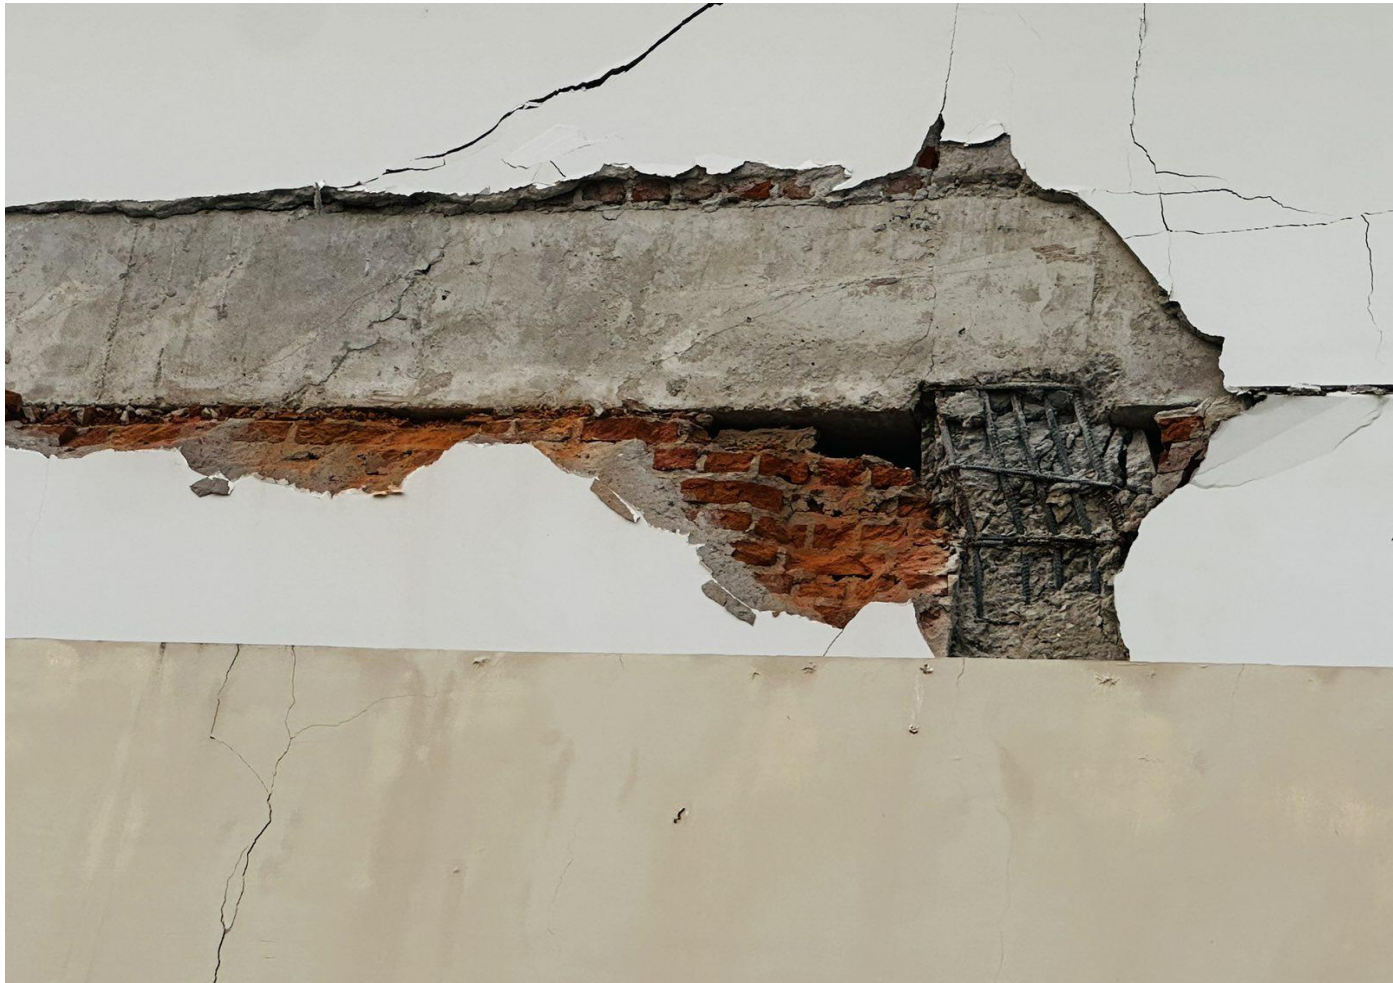
### Failure of Column in Shear

Improper confinement of longitudinal bars led to shear failure column during earthquake

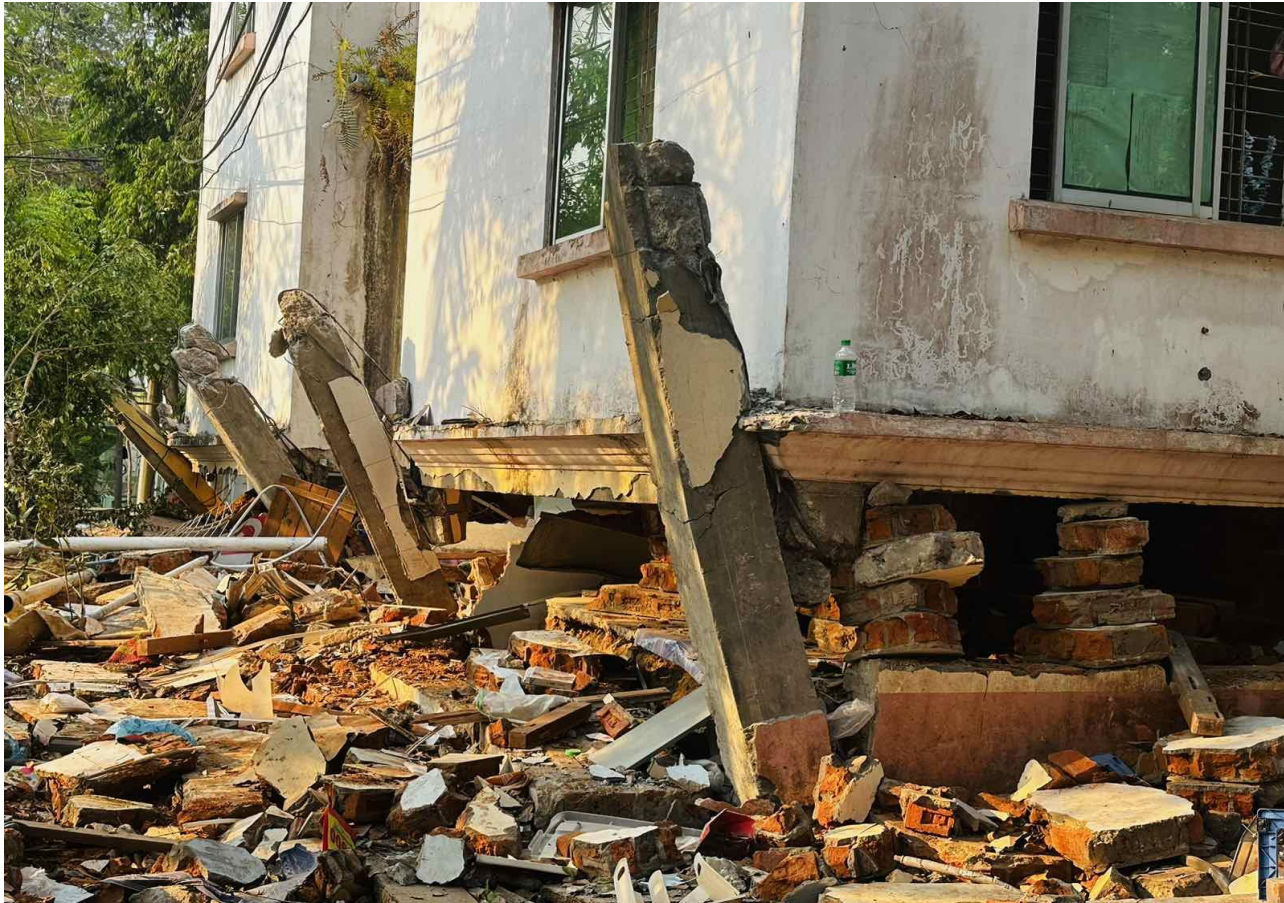
## Open Ground Storey

Upper storey stiffened by brick walls and less stiffer ground floor

Failure of columns because of poor energy dissipation capacity

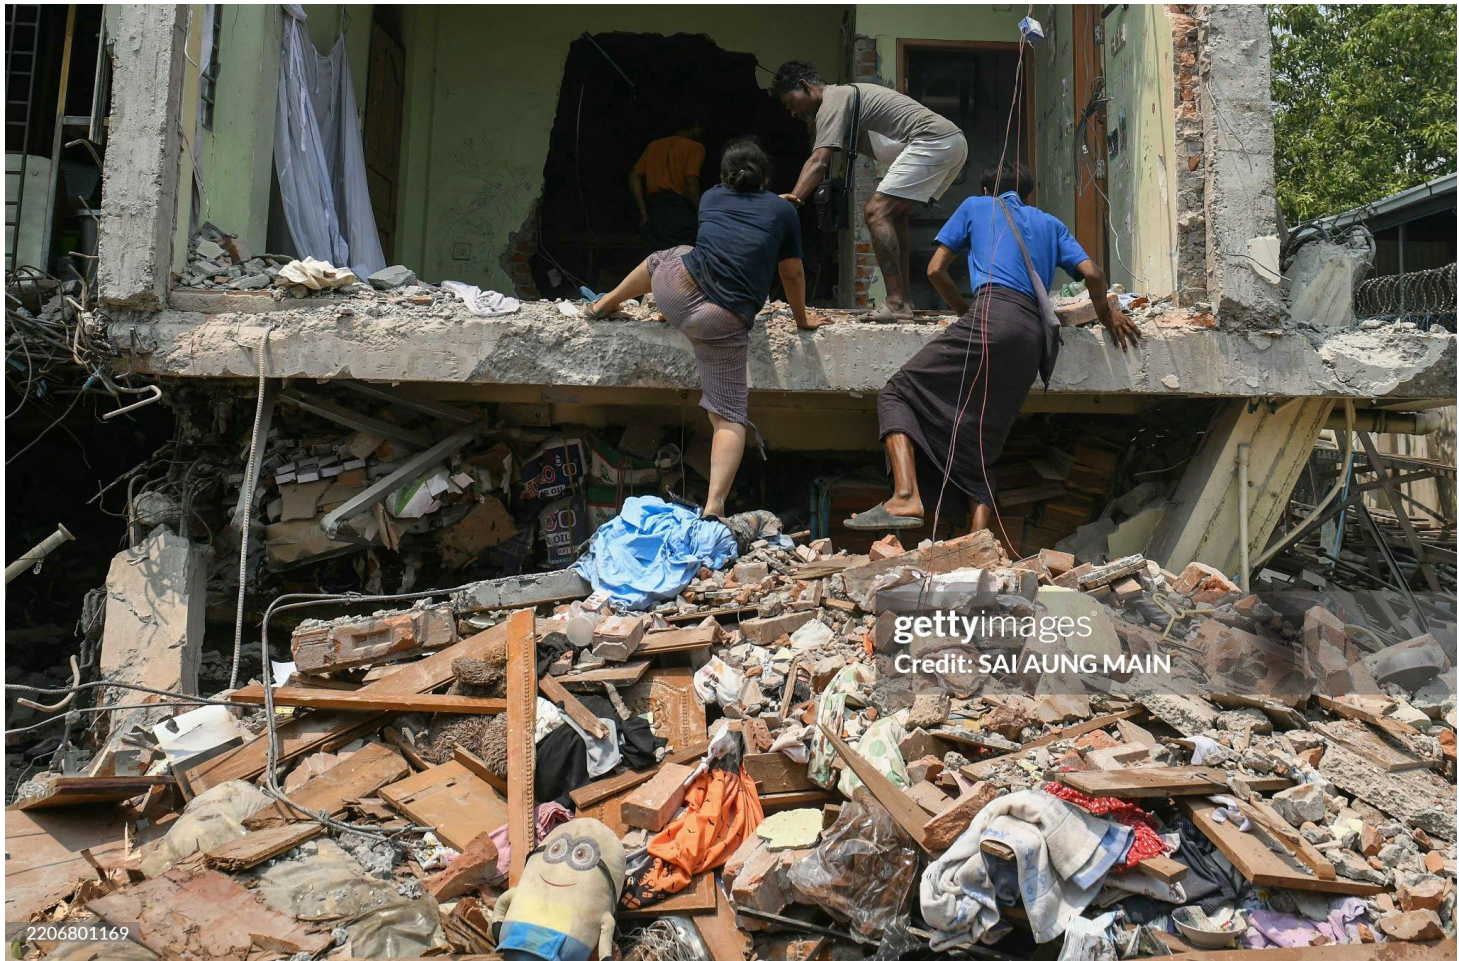
Failure of building due to weak column strong beam

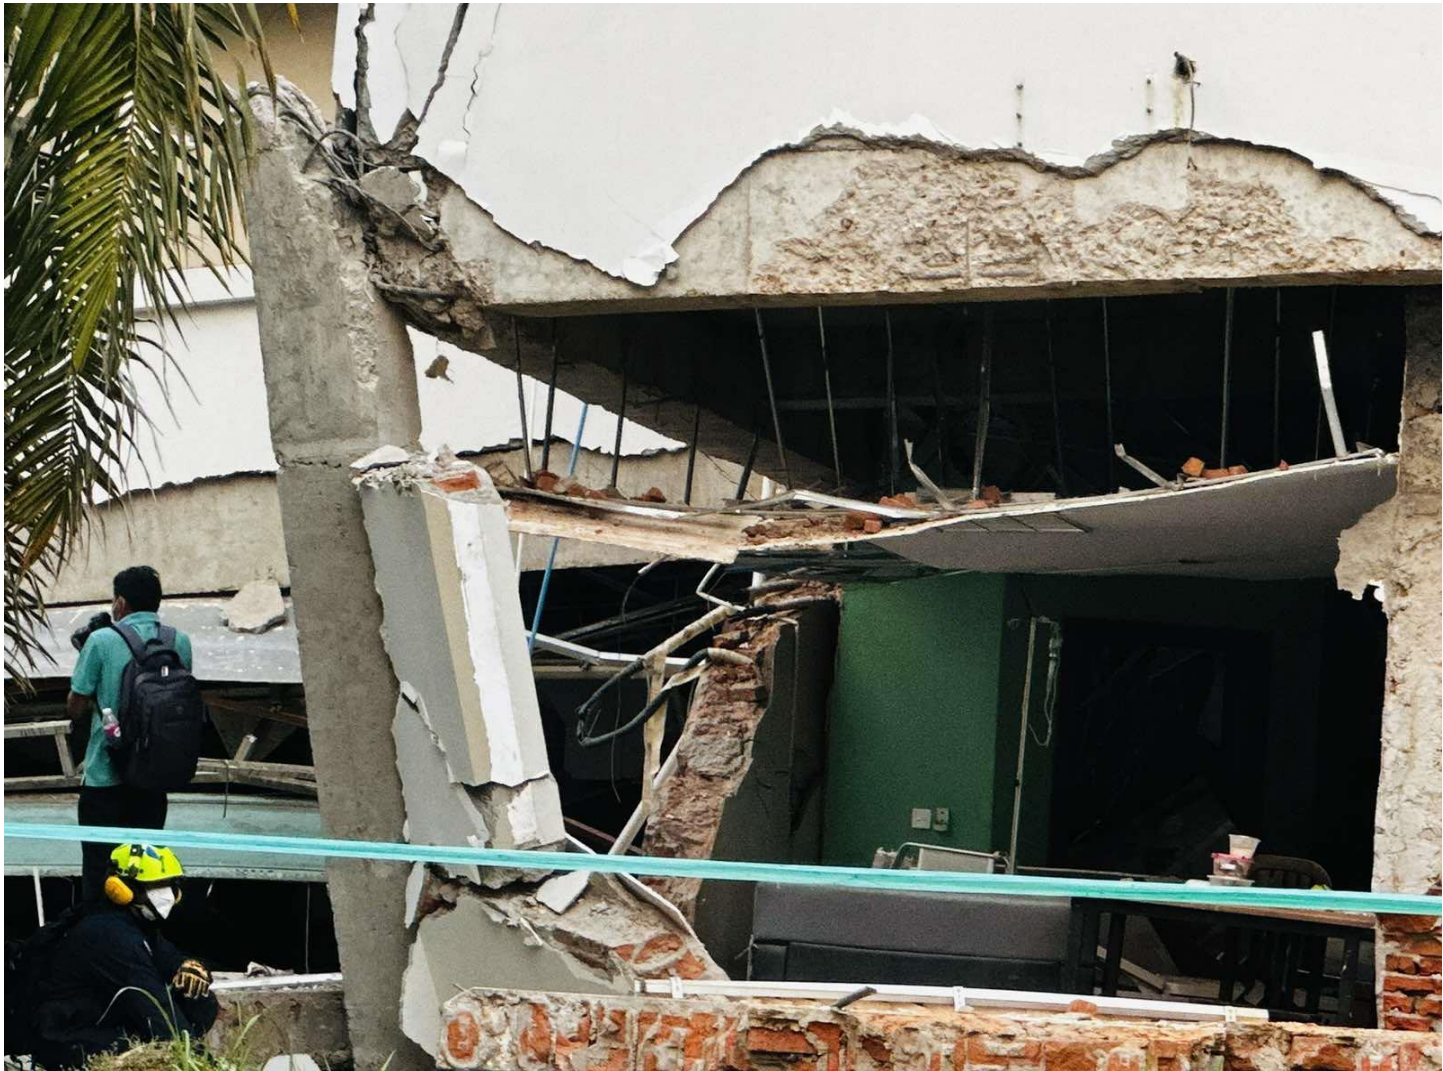
Failure of column due to captive effect

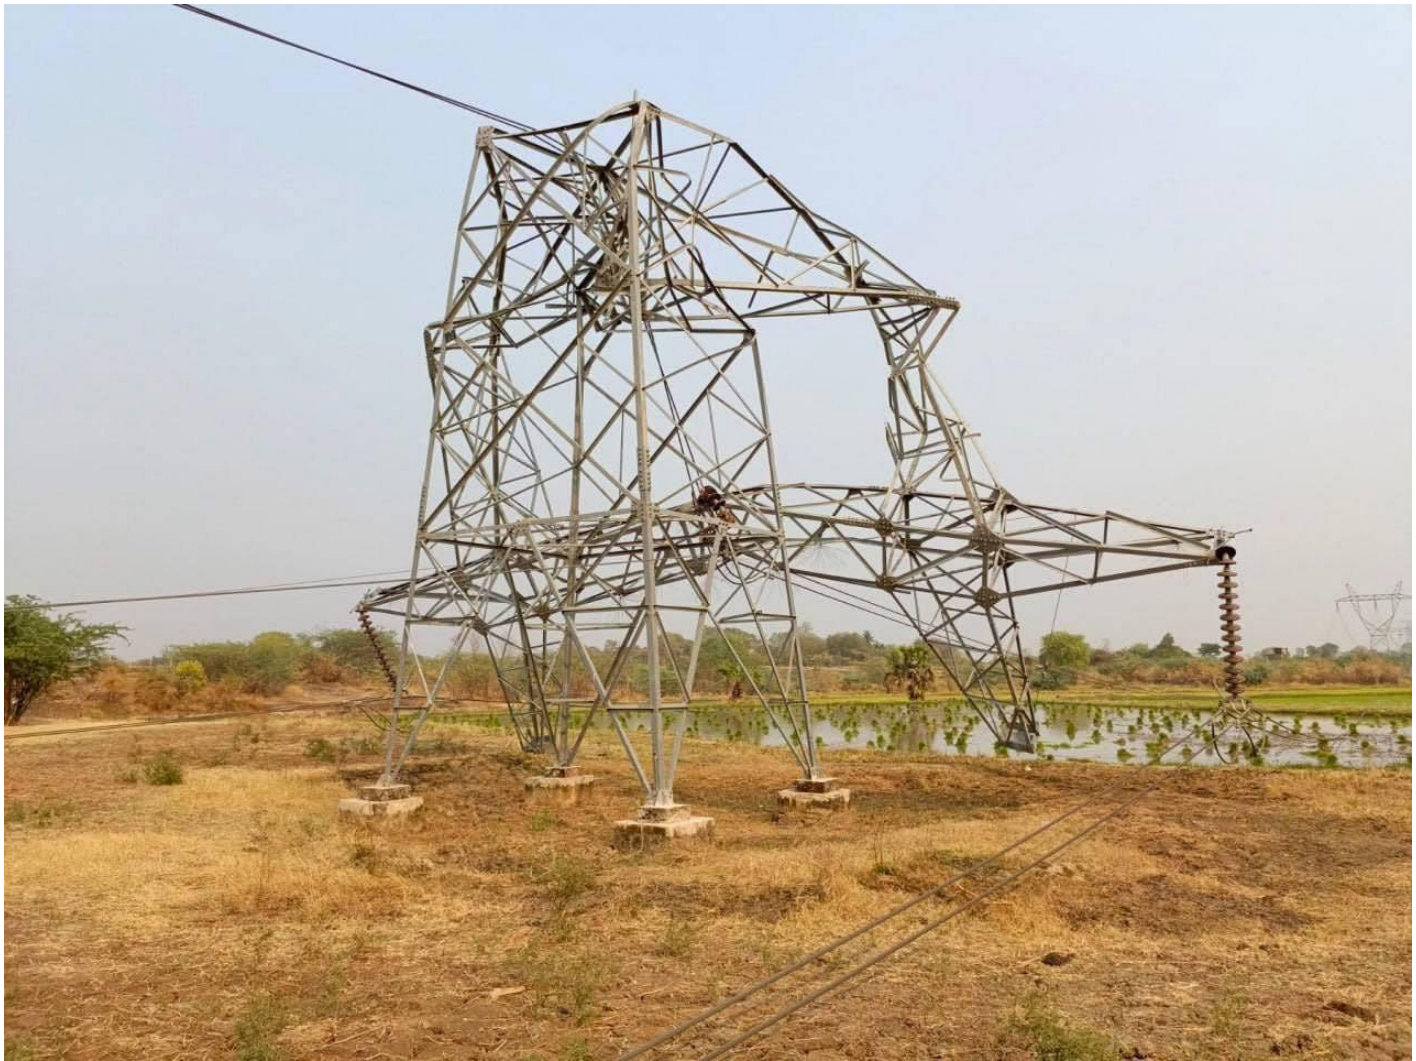
Failure of steel frame due to warping torsion
